Application for a Resource Consent – Resource Management Act 1991

Replacement and minor upgrade of a culvert and tidal flap gate on Whangaroa Road, with ancillary works either side of the culvert.

Resource Consent Application - Whangaroa Road Culvert Replacement

Appendix B – Hydrological and Hydraulic Calculations

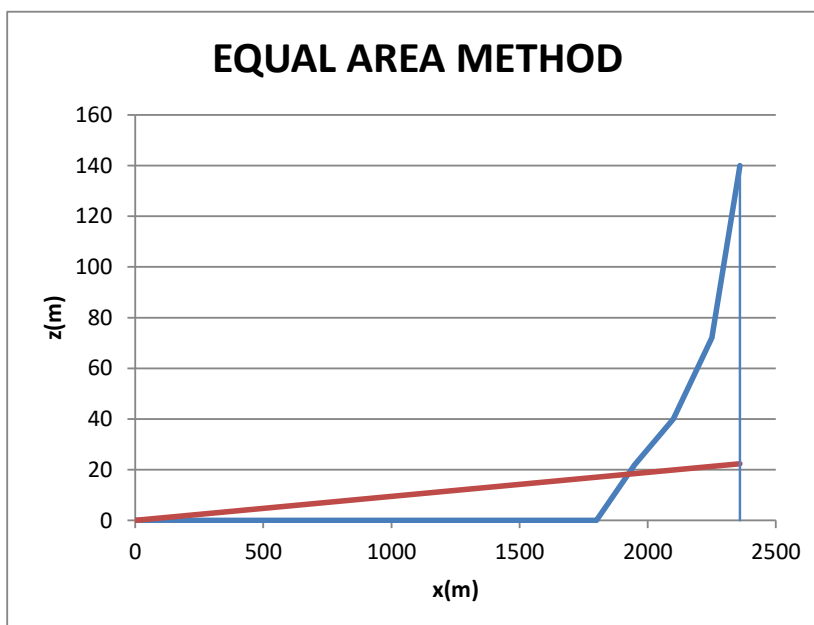
TP 108 -Time of Concentration	
Channel Length L (km)	2.36
Slope S _c (m/m)	0.009
Channel factor C ₁	1
Channel factor C ₂	0.8
CN ₁	80
CN ₂	98
tc ₁ (min)	74.89
tc ₂ (min)	49.00

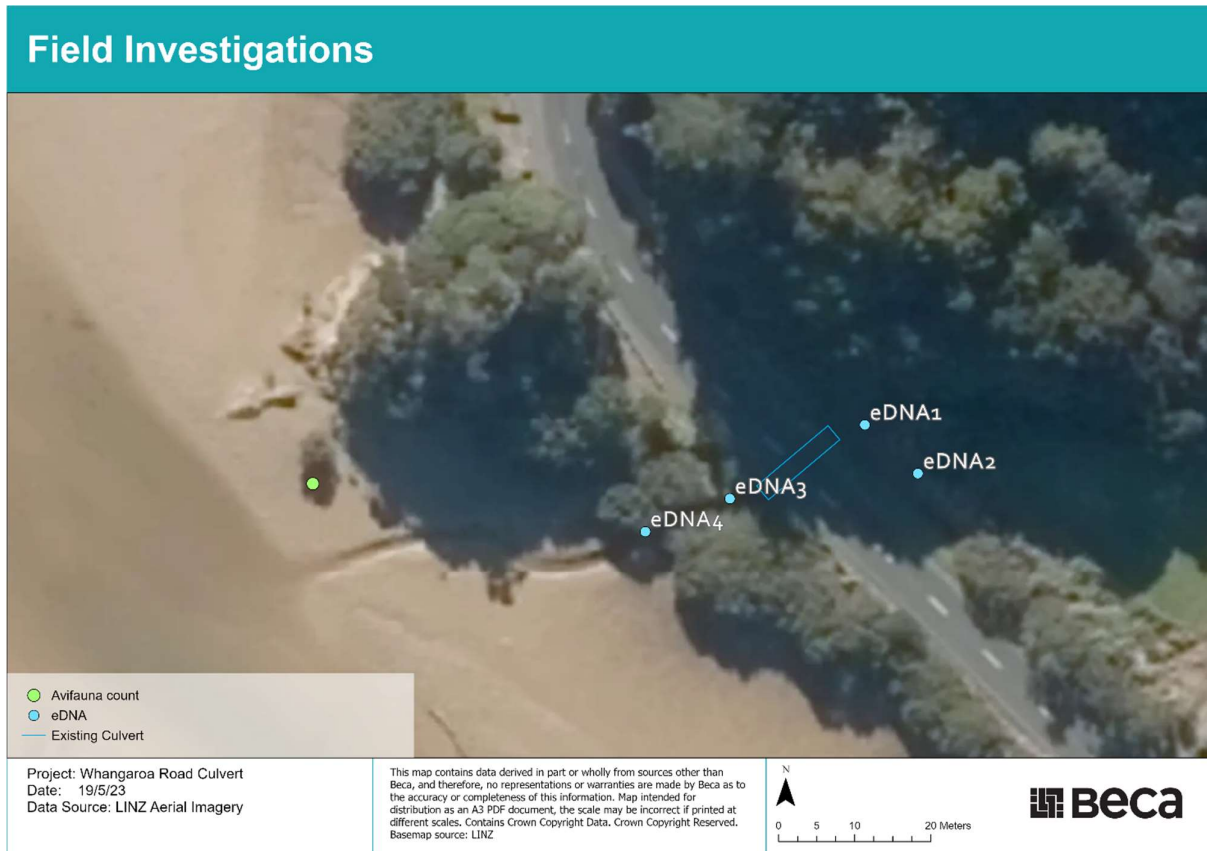
Figure 3. Locations of eDNA samples and avifauna count undertaken on site.

One bird count was undertaken with one observer walking a short 67 m transect at low tide (~12pm) from the culvert to beyond the mangroves and scanning the harbour (see Figure 3). All shorebird species sighted were identified and recorded along with behaviour at the time of observation.

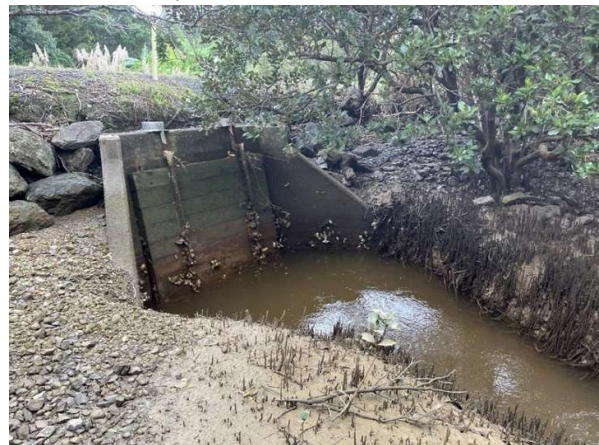
Watercourse 1 upstream of the culvert

Small unnamed watercourse at confluence with Watercourse 1

Watercourse 1 downstream of the culvert

Figure 4. Photos of Watercourse 1 taken on 18th May 2023.

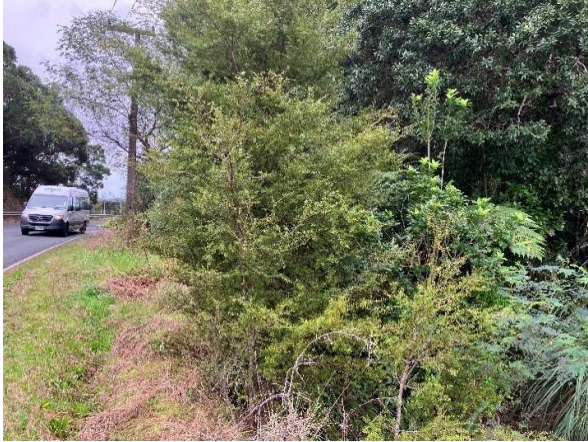
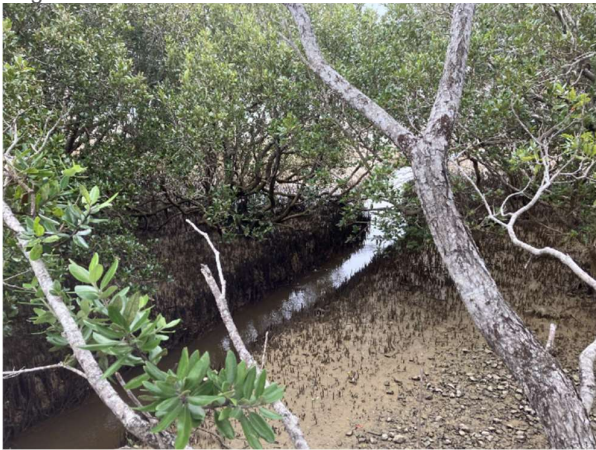
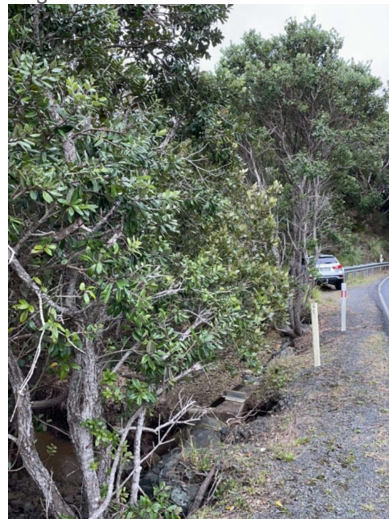
Vegetation to the north west of the culvert

Vegetation to the south of the culvert

Vegetation adjacent to the south of the culvert

Figure 7. Photos of Vegetation adjacent to the culvert on Site taken on 18th May 2023

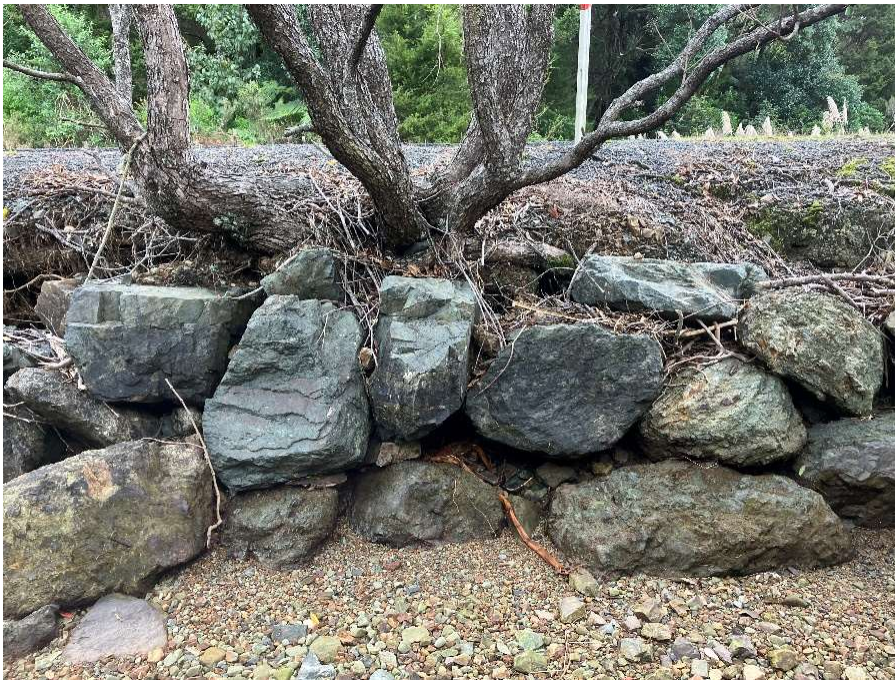
Figure 9. Rock armour adjacent to culvert.
