Application for a Resource Consent – Resource Management Act 1991

Replacement and minor upgrade of a culvert and tidal flap gate on Whangaroa Road, with ancillary works either side of the culvert.

Resource Consent Application - Whangaroa Road Culvert Replacement

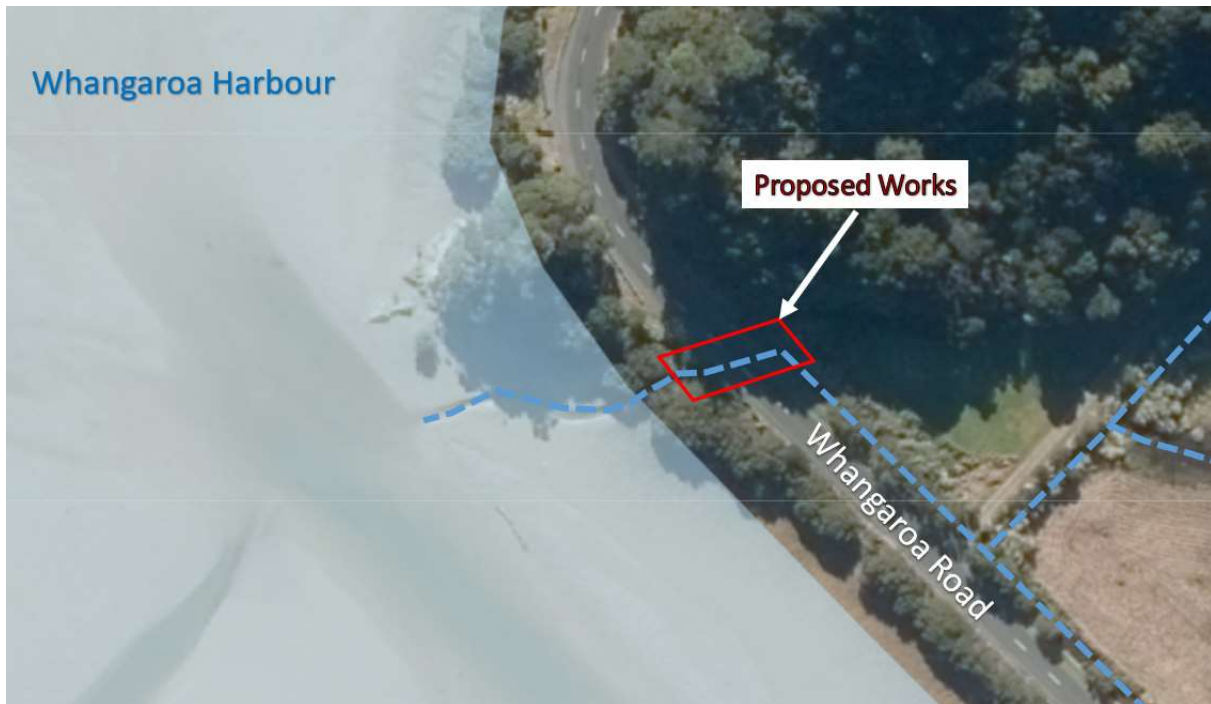
Figure 2.1. Aerial of proposed works area adjacent to the General Coastal Marine Zone / Significant Marine Mammal and Sea Bird Overlay (Proposed Northland Regional Plan Maps) shown as a blue overlay within the Whangaroa Harbour. Freshwater streams / drains are shown as dashed blue lines.

At present, drainage channels / streams carry freshwater flows from the catchment to the 1.8x1.8m box culvert. The channels are incised with steep banks on both sides of the road. The ground and intertidal foreshore downstream of the culvert comprises soft marine silts and mud. A mature mangrove forest has established within the intertidal margins along the shoreline.

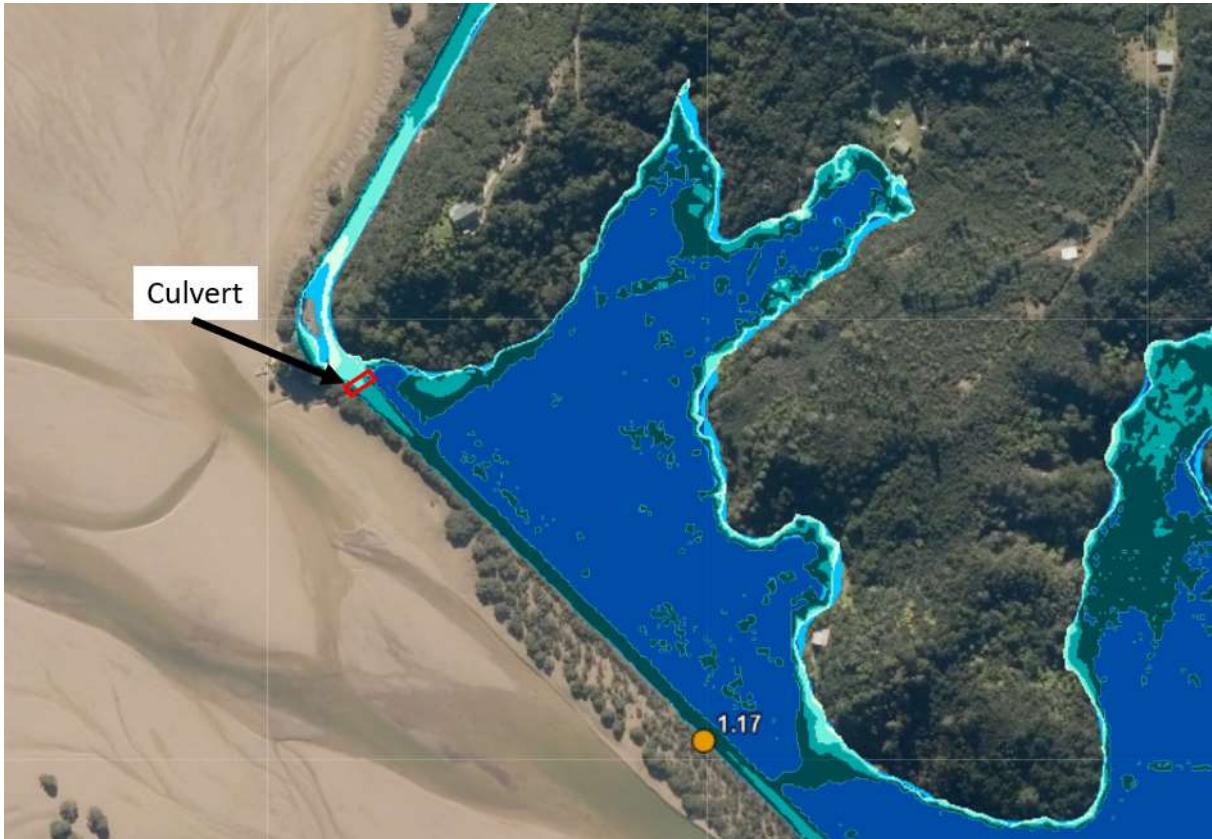
Figure 2.3. NRC GIS Natural Hazard Maps showing the contributing catchment within the Coastal Flood Hazard Zones 2 and 3.

Based on the NRC modelling reviewed by the design team, it is expected that in extreme events during high tide, coastal waters could likely overtop Whangaroa Road. The existing tidal flap gate is assumed to have been installed to minimise the frequency of coastal inundation and would be effective for all events that did not result in overtopping.

Figure 2.3 below shows the modelled extent of coastal flooding within the catchment (NRC GIS Natural Hazard Maps).

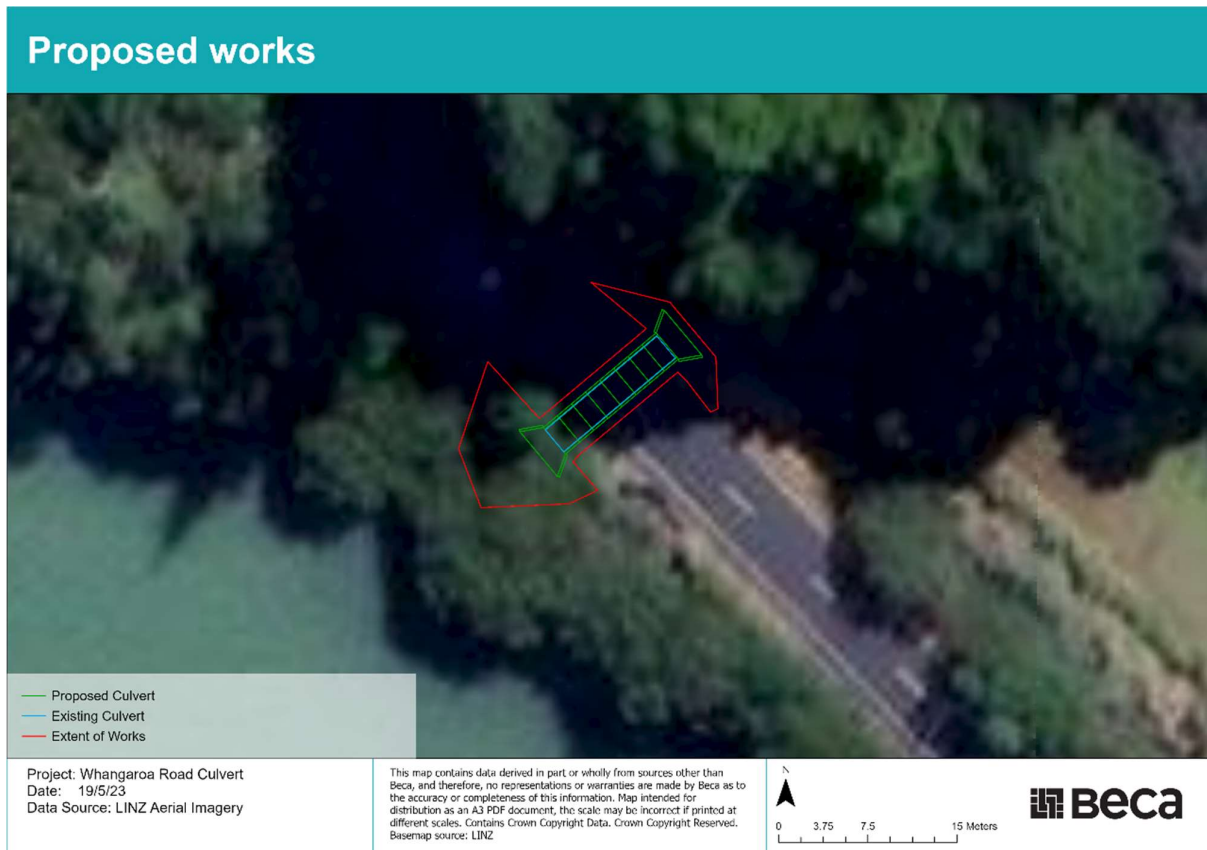
Figure 3.1. Indicative area of the proposed works overlaying an aerial photo of the site. The proposed structure is shown in green and blue with the extent of the earthworks and disturbance in red.

It is proposed to replace the existing culvert and flap gate with a 2.5 x 2.0m concrete box culvert and an upgraded flap gate to cover the increased cross-sectional area of the culvert. This culvert design will reduce the risks of flood flows overtopping the road surface and subsequent damage. This also will reduce the velocity of flows at the outlet during a 100year ARI event to 3.82m/s.

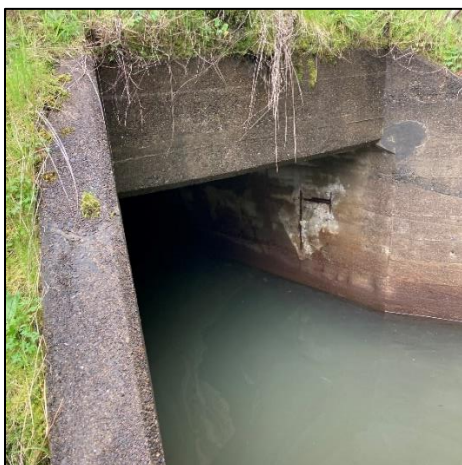
Figure 2: Culvert Inlet

It is a 1.8m x 1.8m reinforced concrete box culvert approximately 11 m long at soffit level and 16.5m long at invert level (including apron). Both the inlet and outlet of the culvert have concrete wingwalls (refer to Figure 2, Figure 3, and Figure 4 below). The culvert is in a tidal location and is exposed to immersion in saline/brackish seawater. There is a tidal gate at the downstream end of the culvert. The structure was not considered as a council asset for a significant portion of its life, and hence, has never been maintained.

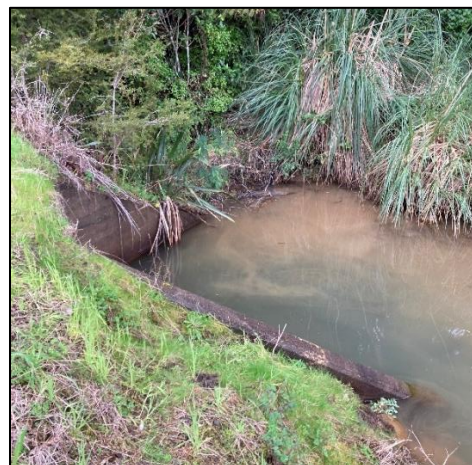
Figure 3: Culvert Inlet

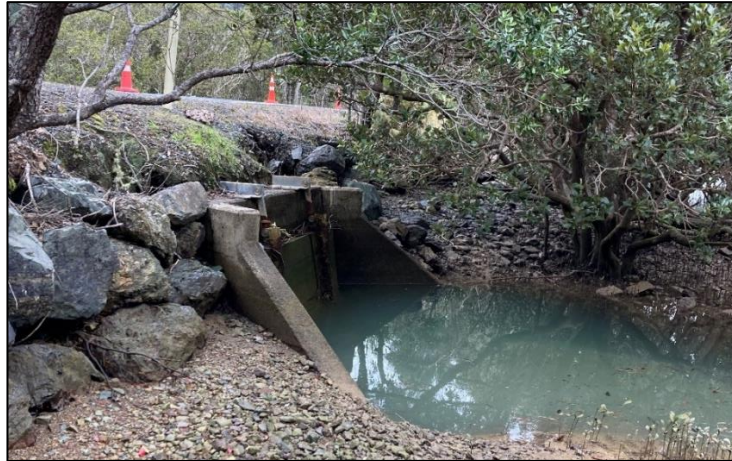
Figure 4: Culvert Outlet

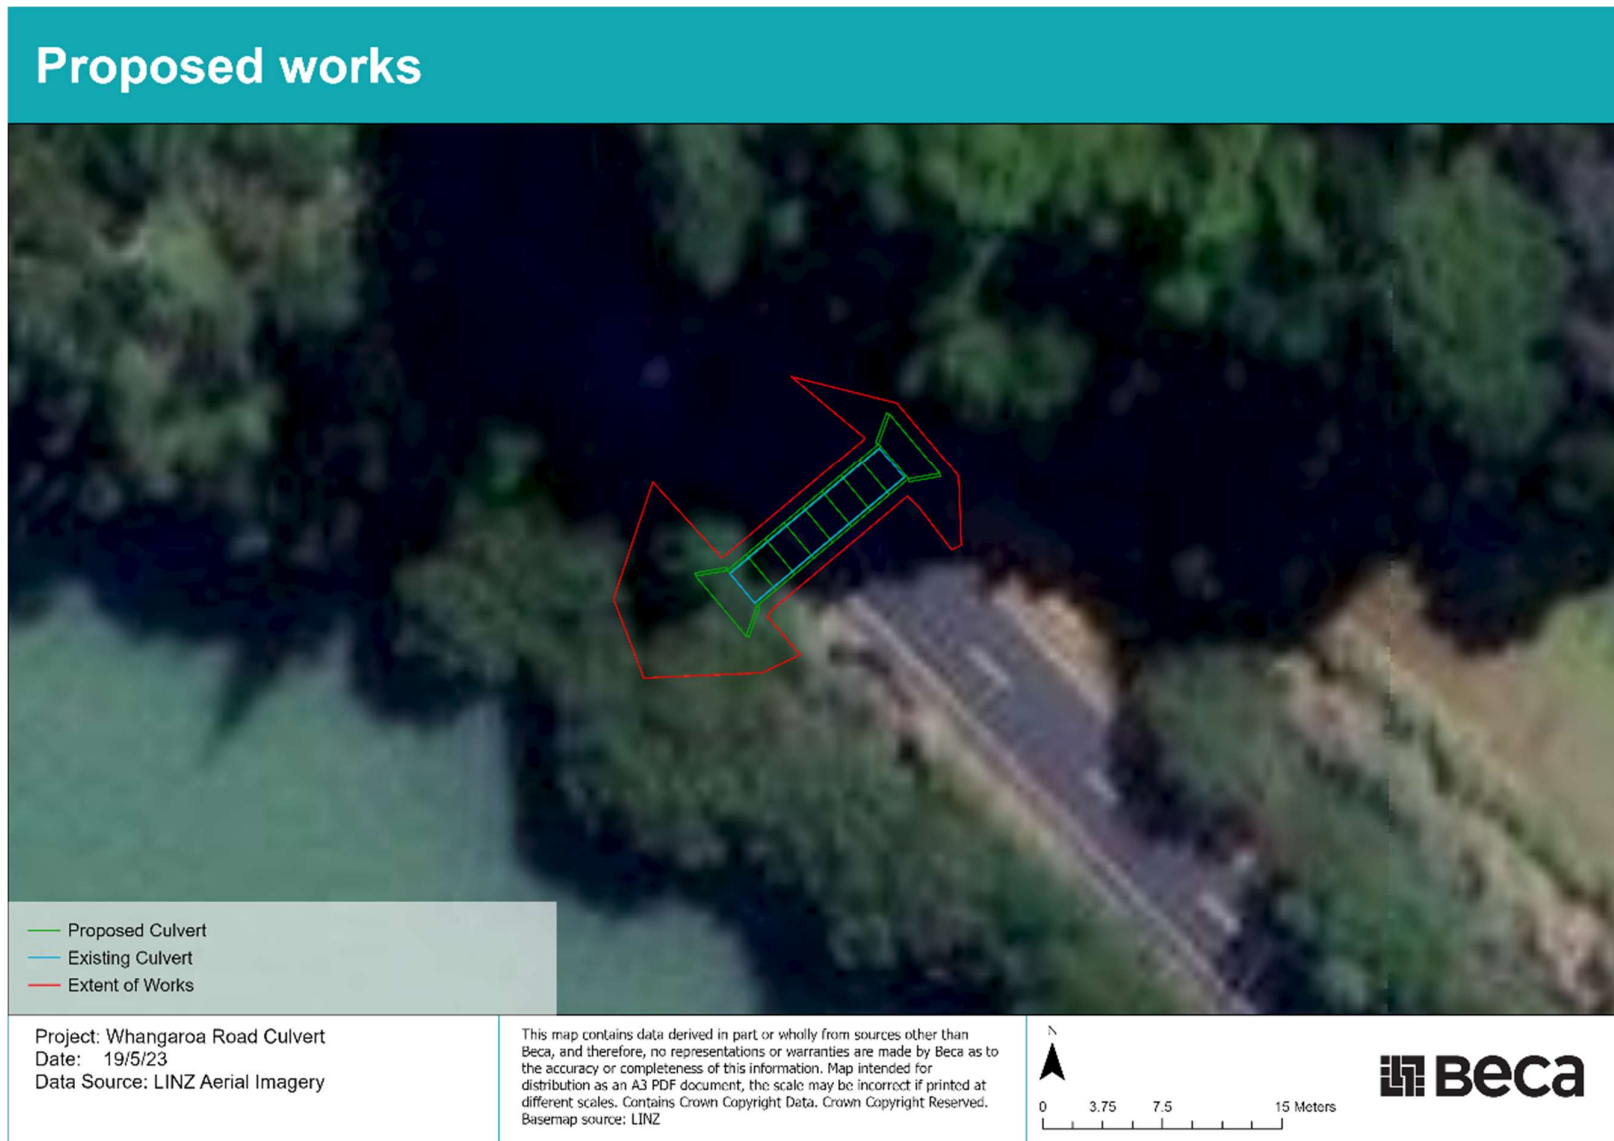
Figure 1. Location and extent of proposed works.

The Whangaroa Road culvert UN28 is a 1.8m x 1.8m reinforced concrete box culvert approximately 11 m long at soffit level and 16.5m long at invert level (including apron). The culvert is in a tidal location and is exposed to immersion in saline/brackish seawater. Both the inlet and outlet of the culvert have concrete wingwalls and an apron. There is a tidal gate at the downstream end of the culvert. The culvert has been identified as requiring replacement due to it being in poor condition as a result of extensive corrosion. The new culvert will also require a tidal gate to protect the upstream environment from sea surge. Indicative design of the proposed culvert and extent of works is shown in Figure 1.

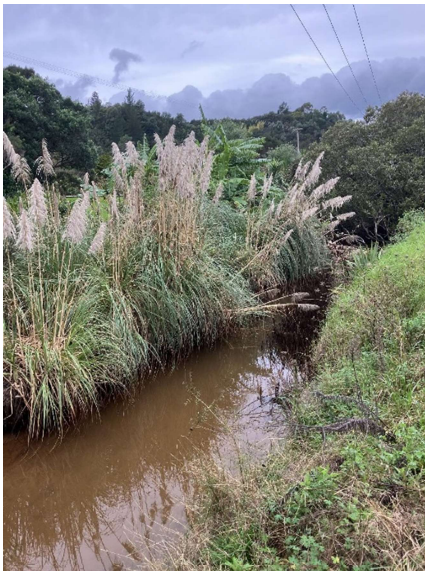
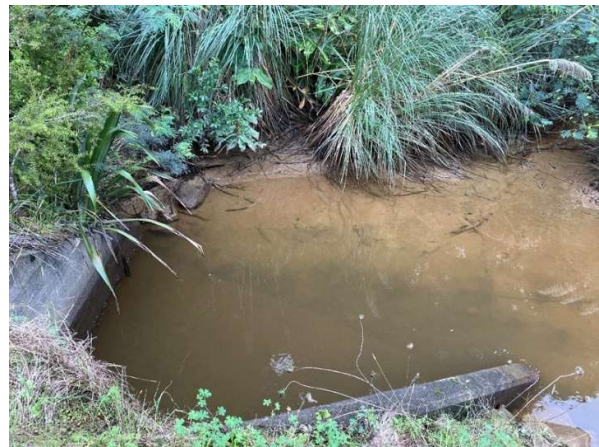
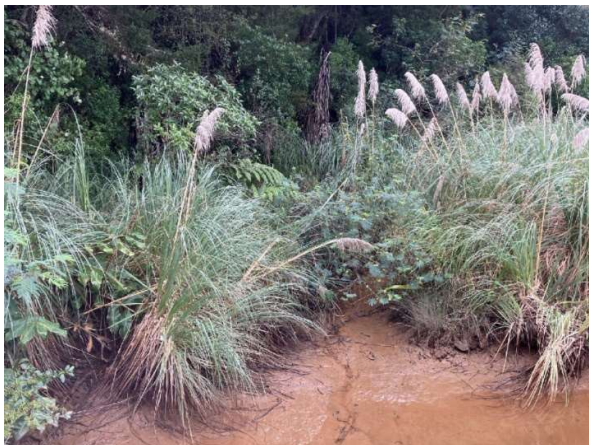
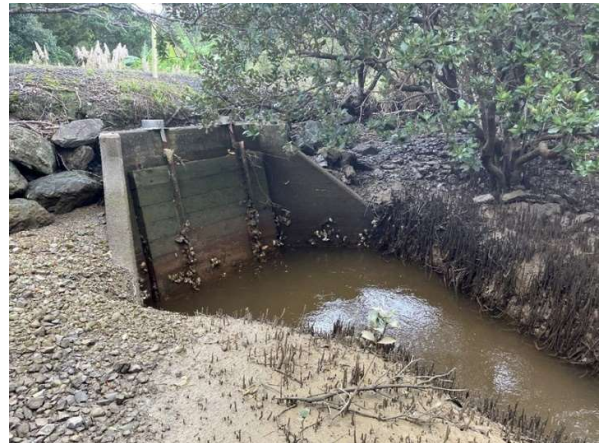
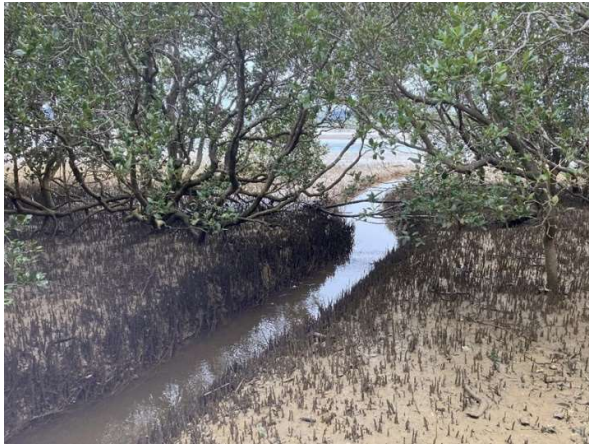
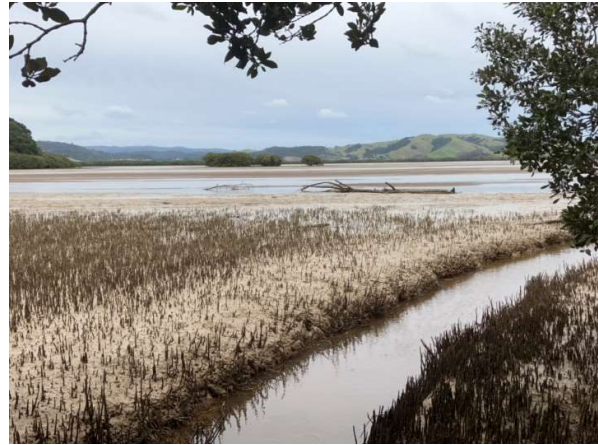
Figure 4. Photos of Watercourse 1 taken on 18th May 2023.
